# **Watts Branch, Washington, D.C. Watershed and Stream Assessment**

*CBFO-S02-03*

Prepared by Christopher K. Eng, Project Manager

U.S. Fish & Wildlife Service  
Chesapeake Bay Field Office

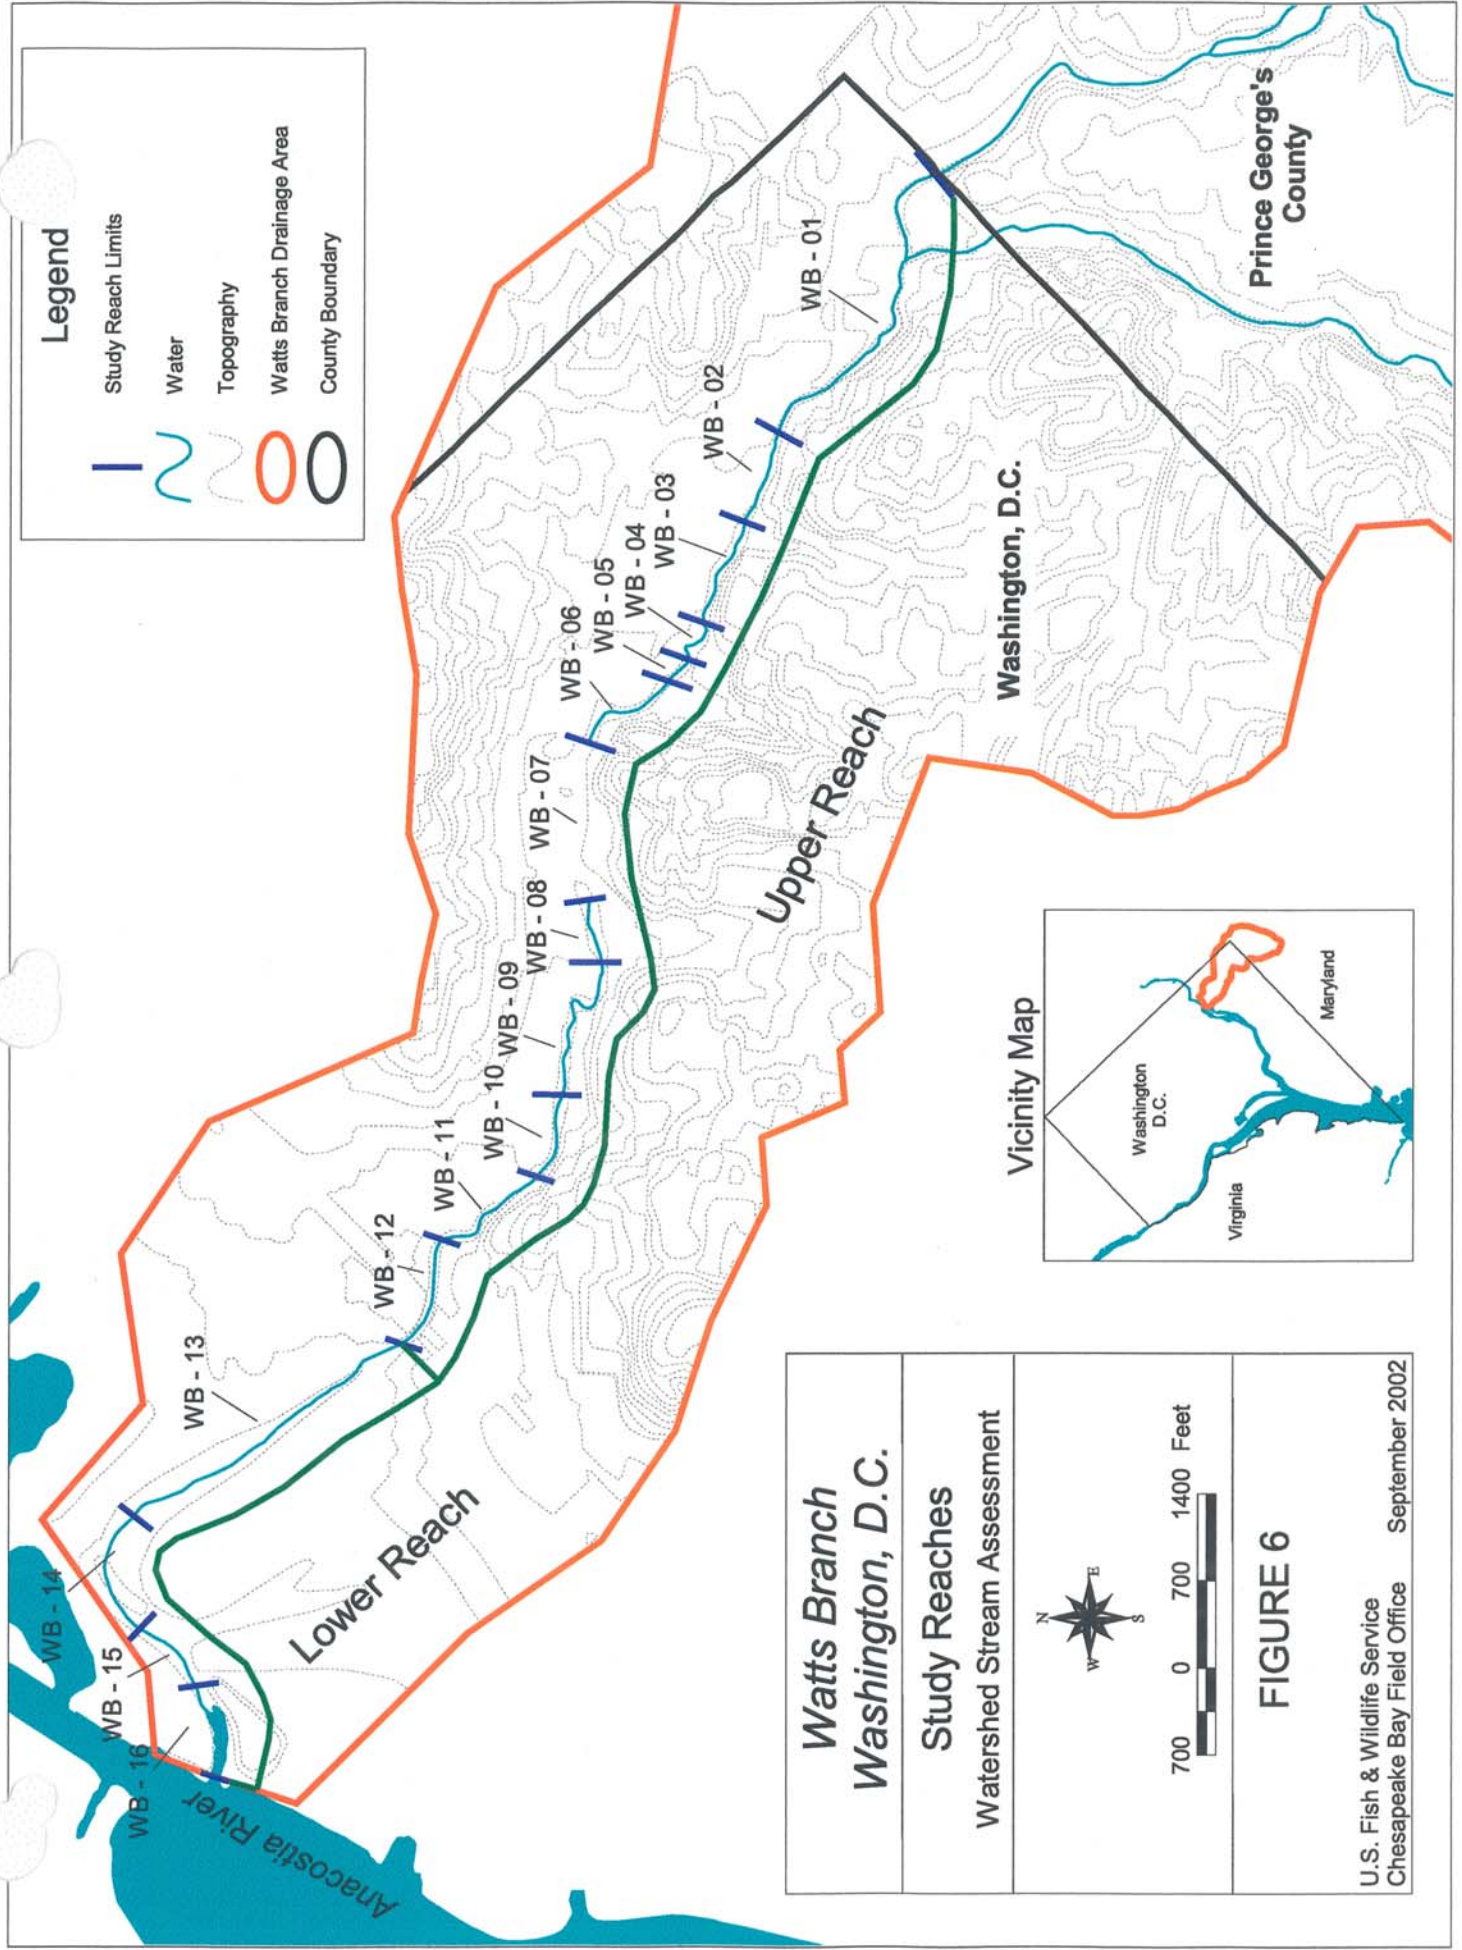
<b>Watts Branch Washington, D.C.</b>	
<b>Study Reaches</b>	
Watershed Stream Assessment	
<p><b>FIGURE 6</b></p> <p>U.S. Fish &amp; Wildlife Service Chesapeake Bay Field Office</p> <p>September 2002</p>

The Upper Reach of Watts Branch is significantly impacted by urbanization and stream alterations. The flow regime for the stream has changed in response to the urbanization and land use changes. Changes to the flow regime include increased stormwater runoff, peak discharges, and increased flashiness. The stream has also been channelized and its floodplain lost due to floodplain fill and/or channel capacity enlargement.

In response to the urbanization and stream alterations, the stream is actively adjusting to accommodate the higher discharges within the channel. These adjustments are indicative of the significant instability found in the Upper Reach of Watts Branch. Reaches WB-01 to WB-09 are both vertically and laterally unstable. Reaches WB-10 to WB-12 are stable with localized areas of instability. The Service identified approximately 2,647 linear feet of moderate to high erosion along the stream, which is approximately 25 percent of the Upper Reach. The moderate to high erosion is due to a variety of causes, including moderate to extreme bank erosion hazard indices and moderate to very high near bank shear stress. Some factors which contribute to an increased bank erosion hazard index and near bank shear stress are higher entrenchment, a steeper stream slope from channelization, limited bank and riparian vegetation, less consolidated bank materials, and higher shear stress in the near bank one-third area of the channel cross section. Some of the stream stability is derived from existing stabilization projects, including rip-rap, gabion baskets, and concrete block revetments. This reach has approximately 11,074 linear feet of the stream

stabilization, which is approximately 50 percent of the Upper Reach. The length of stabilization is reported for both banks, where applicable, and thus may exceed the length of the reaches. The stability from these revetments is temporary and some areas are undermined and are falling into the stream. This is a significant concern because the stream has a very high erosion potential. Failure of these revetments will likely result in further lateral erosion and sediment contributions into the stream.
